Geological factors effecting slope instability in the Virginia Coastal Plain: Observations from the 2018 Nottoway Lane Rotational Landslides, King William County

VA Department of Mines, Minerals, and Energy
Division of Geology and Mineral Resources

April 18, 2019

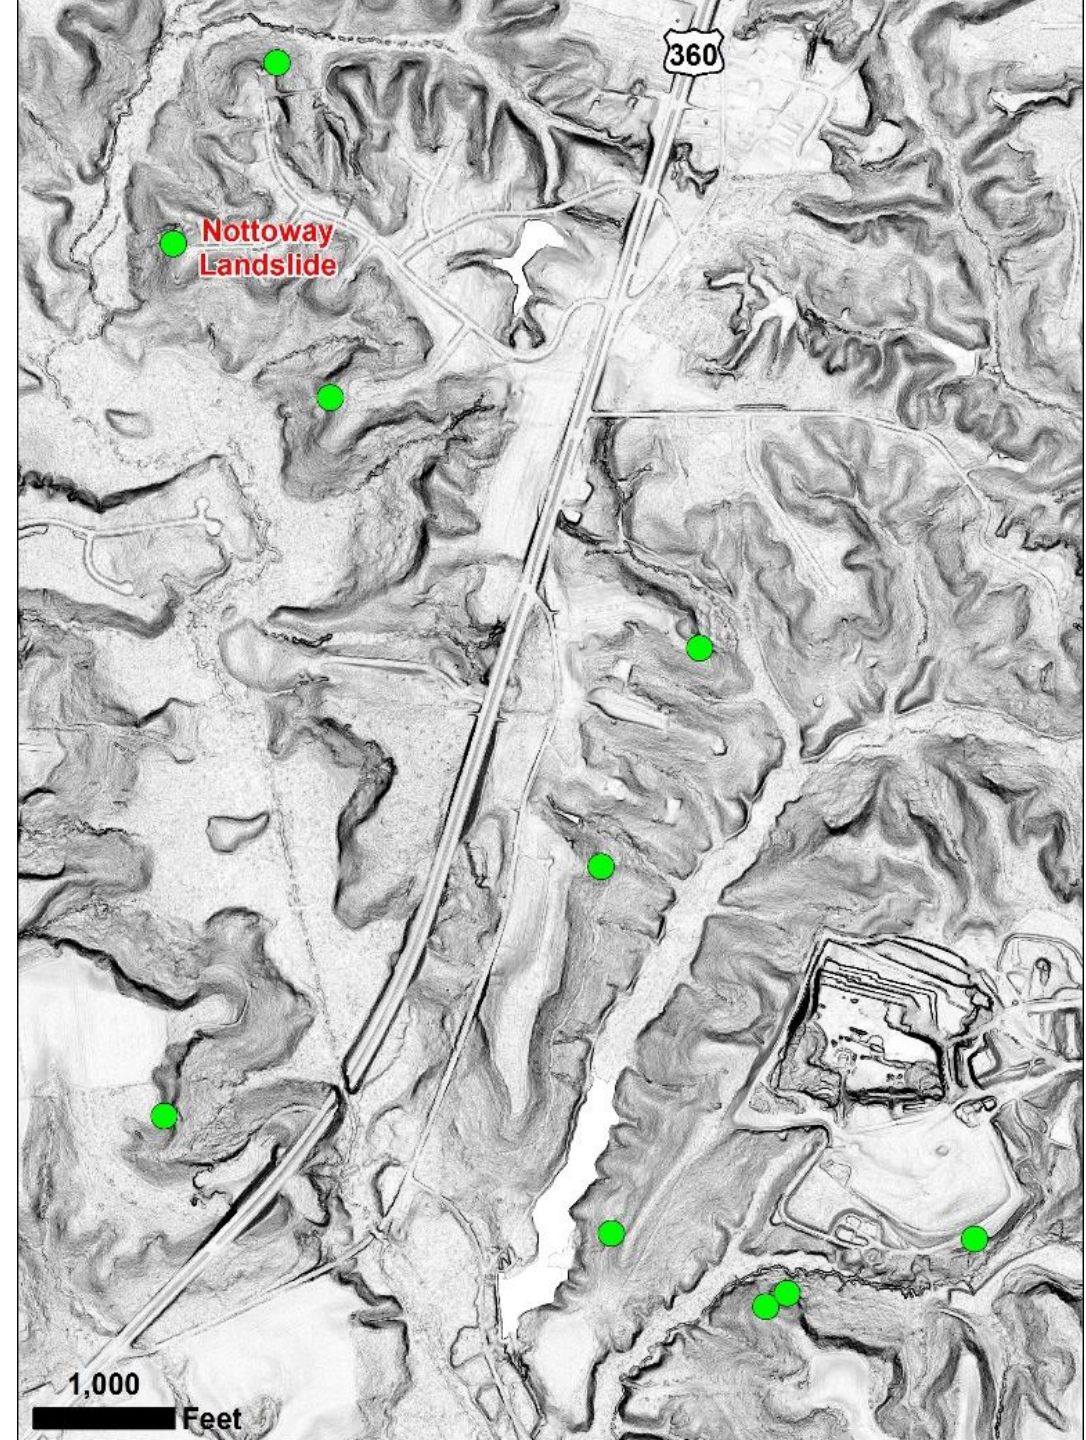
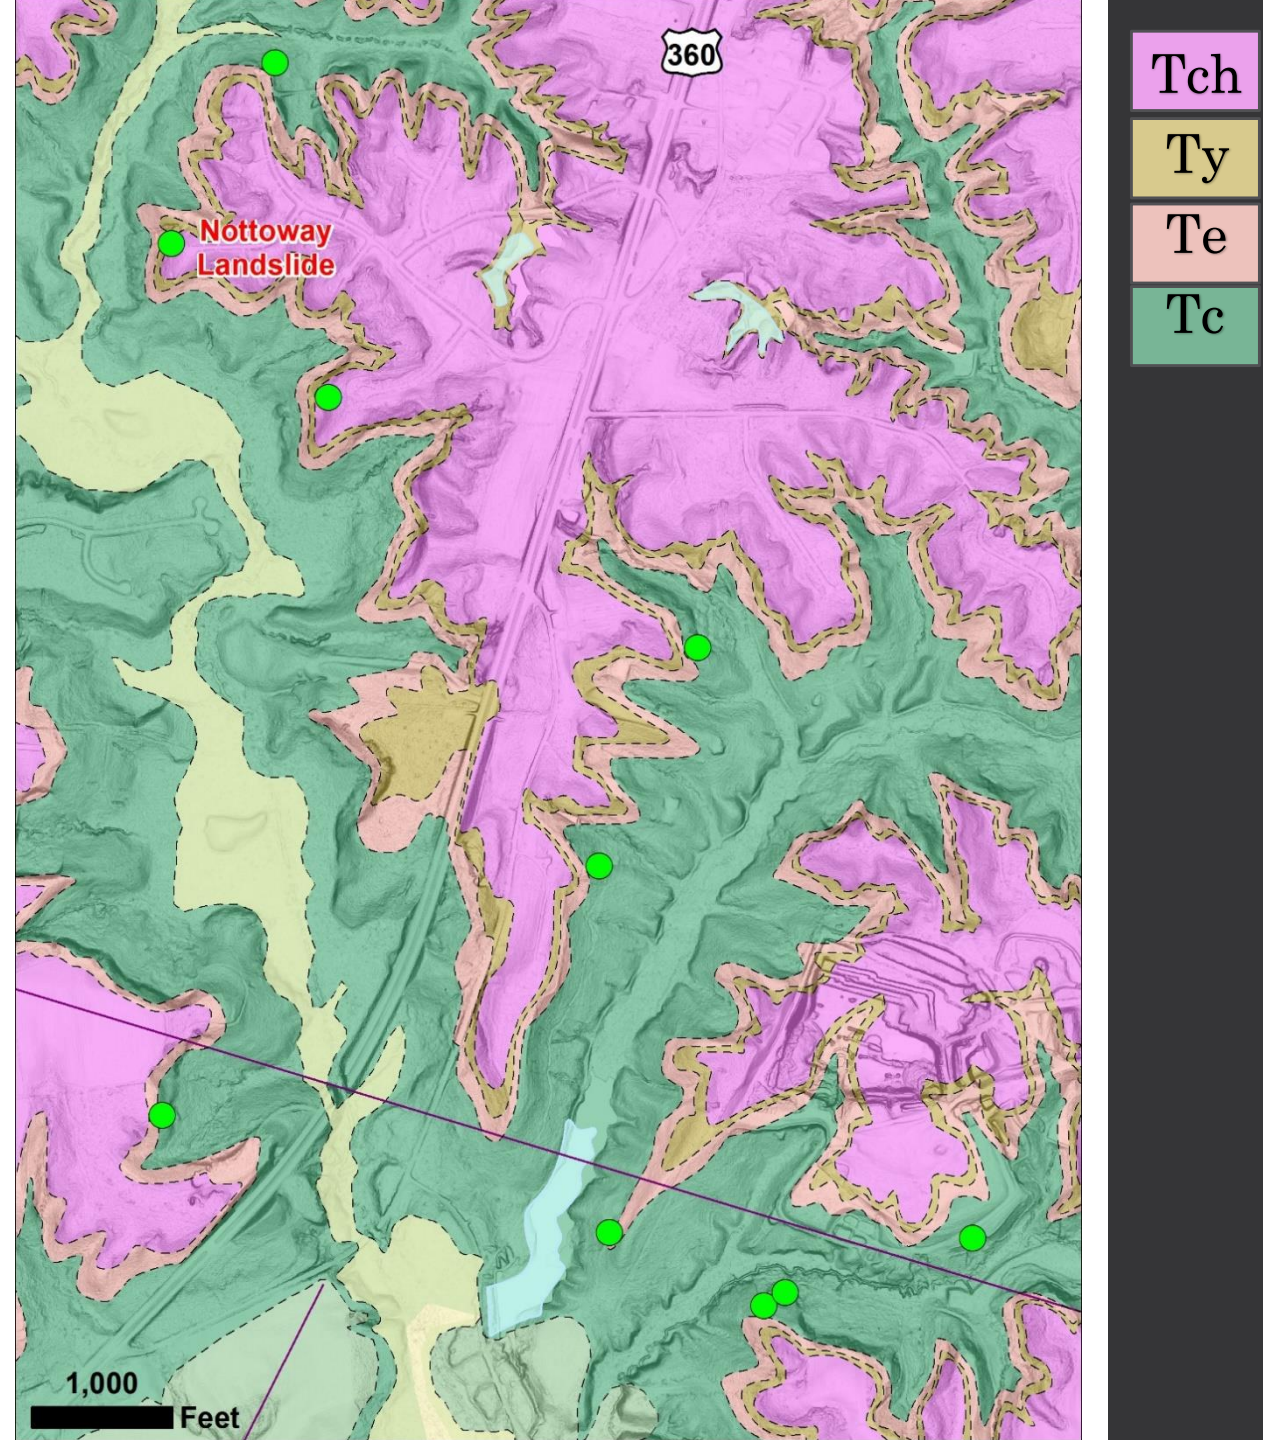
- The Eastover Formation appears to be particularly prone to initiating landslides, especially during heavy rain events
- A first pass through the LiDAR in the immediate vicinity of the Nottoway Landslide identified numerous other debris slides
- Completing a comprehensive landslide inventory for this area using the 2.5-foot LiDAR will be crucial first step to identify areas that are a greater threat to public safety
